D.I.Y. And Save \$100,000

Vince Higginbotham, Manager Testing Services, TestSafe Australia

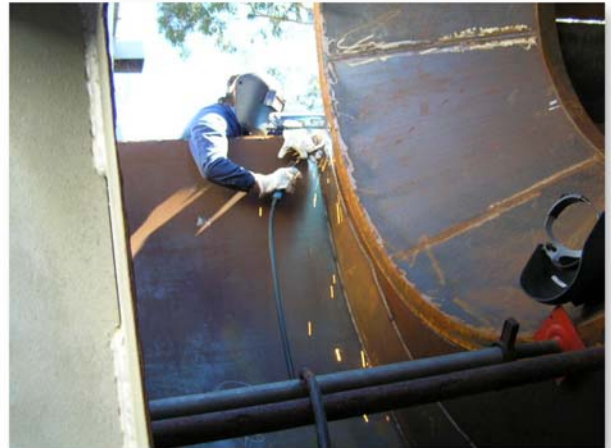
Paul welding in the replacement sections in the base

The top damper section was removed from the assembly first and repairs consisted of removing and replacing all of the flat steel panels. The intermediate section was next and finally the base, which had to be refurbished in situ due to it being part of the fan impeller and motor drive system.

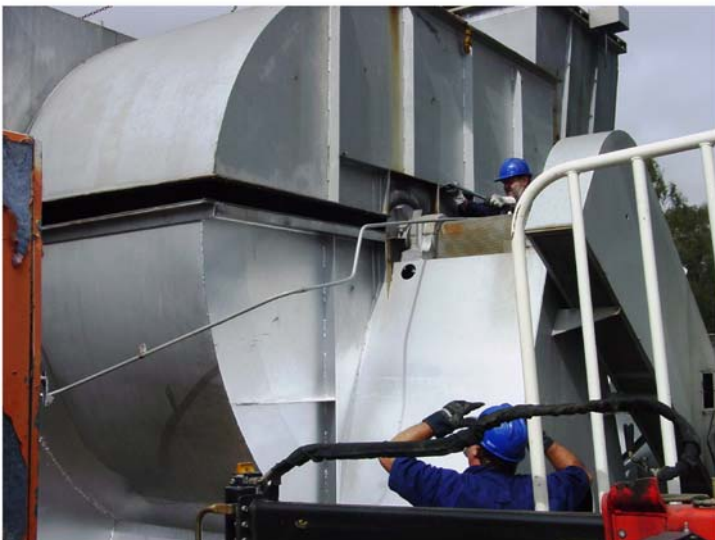
Paul, Dave & Stephen fitting the intermediate section of the fan assembly

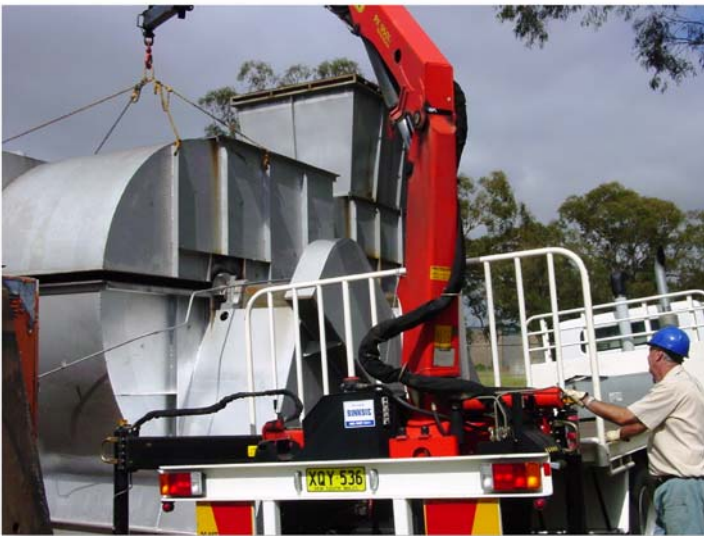
Stephen Hall (from the Core Library) operating the mobile crane during assembly of the fan housing

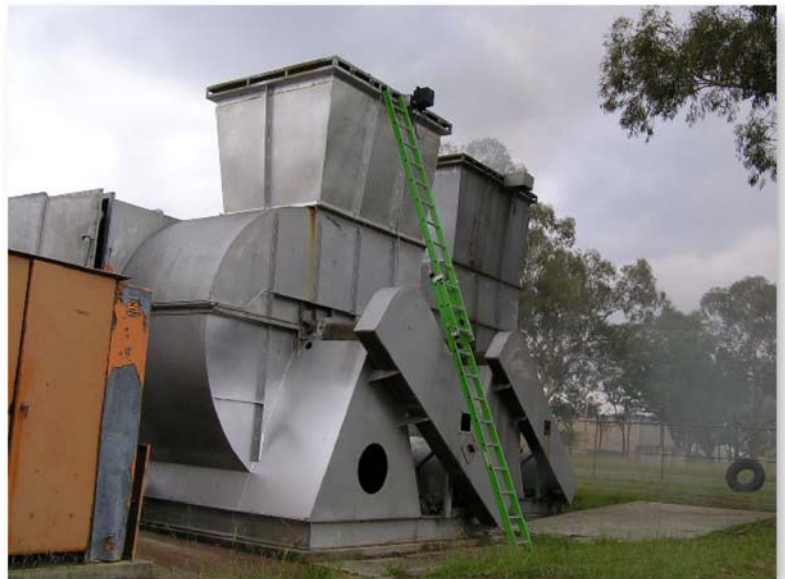
Refurbished fire gallery fan assembly

The refurbishment of the fan assembly was completed and successfully reassembled during December 2005 thanks to the dedicated work of Paul Tilbury, David Wood and much appreciated assistance from Stephen Hall from the Core Library of the Department of Primary Industries/ Minerals.
