Timely Research into Tyre Explosions

Ben Cabot, Fire & Explosion Scientist, TestSafe Australia

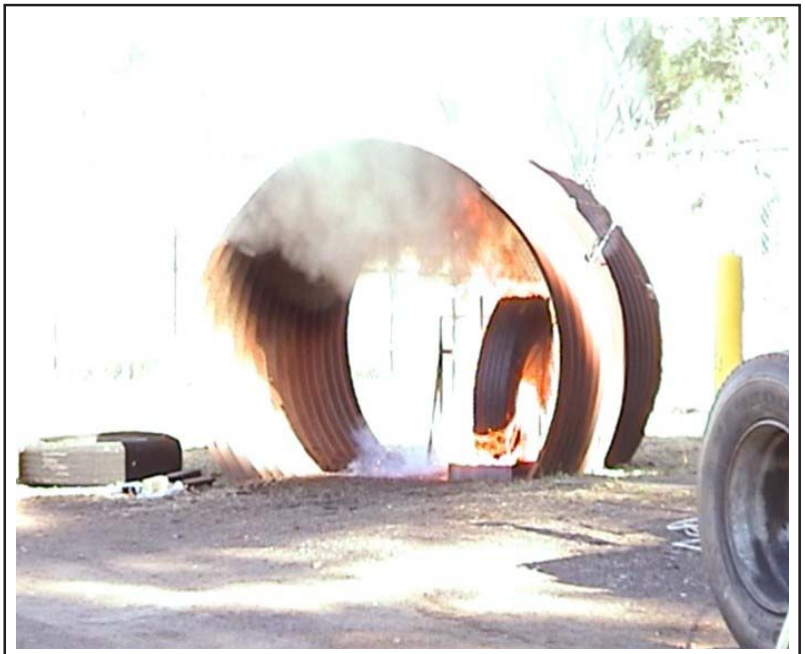
Tyre No 2 - Under Test

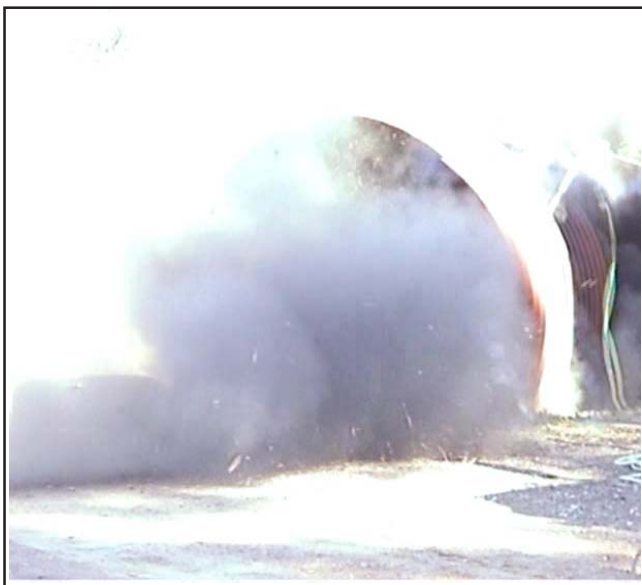
The most spectacular failure occurred during the second tyre test when a large tray of fuel was used to heat the tyre.

After 5 ½ mins, the tyre bead on one side exploded off the entire rim causing permanent deformation and an enormous bang that rattled TestSafe buildings more than 500m away! Before the explosion, in the last 45 seconds of the test, the pressure increased 13 Bar and the temperature increased 300°C. A similar event also occurred during one of the rim heating tests. This suggested that a combustion reaction was taking place inside the tyre, possibly involving fumes from the rubber acting as the fuel.

Tyre No 2 test - Full Extent of Explosion

The research clearly identified the need to extinguish tyre fires as soon as possible (water is suitable), and not to do any work (i.e. welding or heating) on a rim with an inflated tyre attached, regardless of whether air or nitrogen is used to pressurise it.

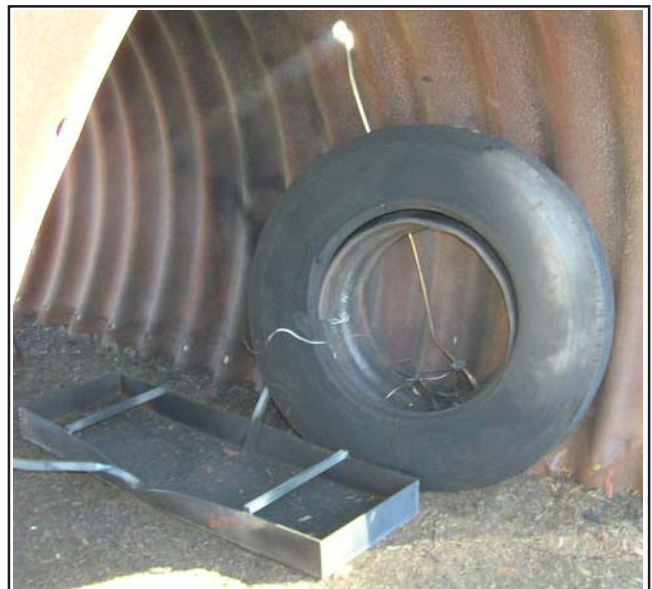
Tyre No 2 test - After Explosion
