North Ryde Gas Explosion

Terry McKay, Assistant Principal Inspector, Hazard Management Group

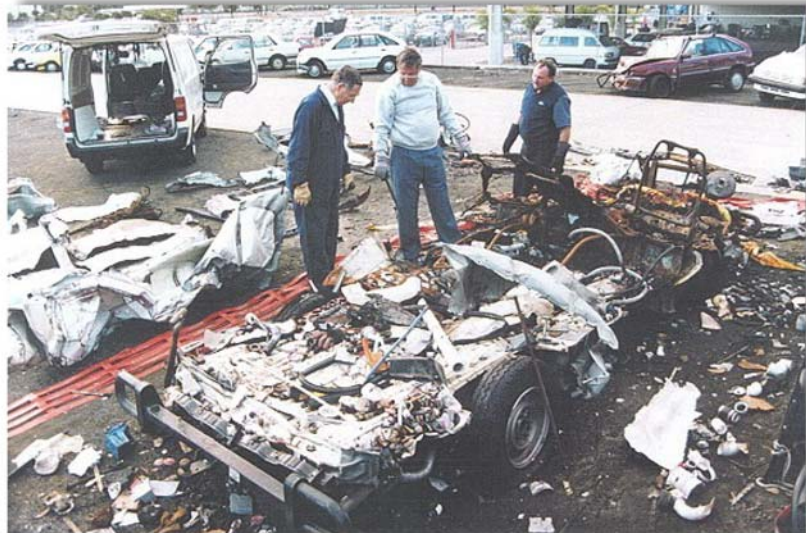
WorkCover Inspector (left) Frank Gilbert at scene of fatality

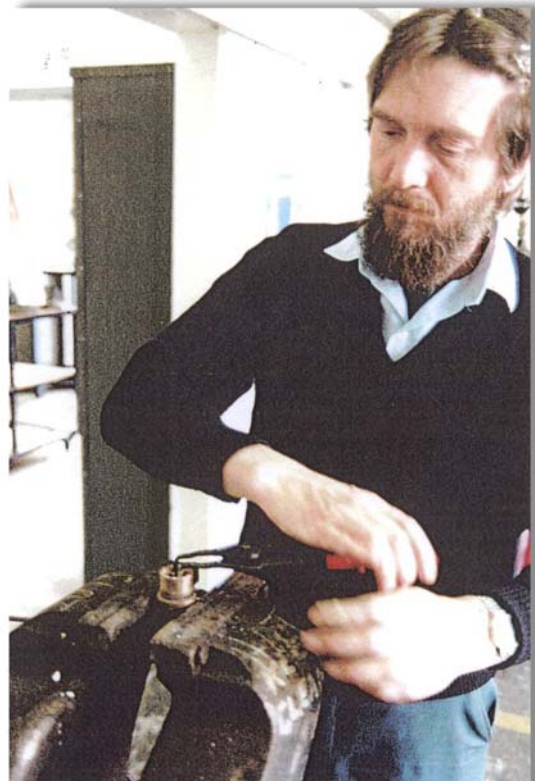
The units were tested by fitting them to a 0.34 kilogram Primus cylinder part-filled with propane and then immersing in water. A graduated glass cylinder was used to collect and measure any leakage observed.

Selected specimens were subsequently dismantled in the mechanical services workshop at Londonderry with the assistance of TestSafe Technical officer, Paul Tilbury. The elastomeric seals located in various components were examined for signs of operational deterioration.

TestSafe's Paul Tilbury testing the brazing tool

Whilst the number of specimens examined was insufficient to form any conclusive opinion of the effectiveness of the design of the several different models of the torches in the group tested, it was noted that the O-ring seal at the base of the torches was the component which most commonly showed signs of cracking and cutting under pressure or through frequent use. This O-ring is intended to maintain a leak-proof seal when a torch control unit is screwed into the self-seal connection valve of a Primus propane cylinder containing liquefied propane, typically at a constant pressure of 750 kPa.

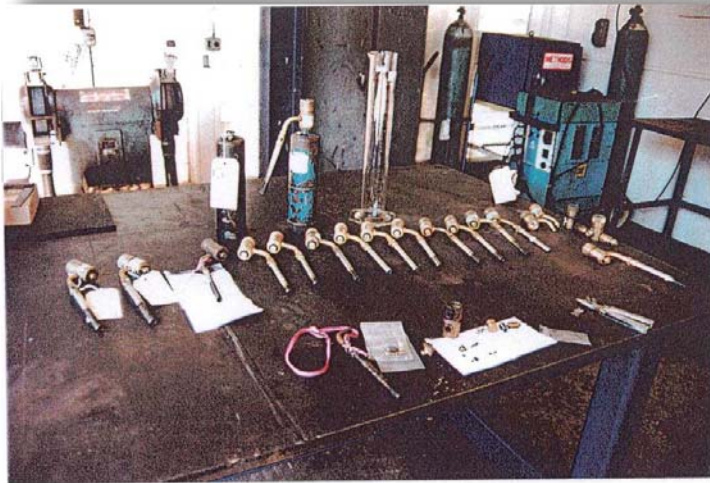
During the investigation by Inspectors Frank Gilbert and Terry McKay it became clear that the portable LP Gas cylinder of 0.34 kg capacity, was loosely attached to a hand-held brazing torch of a type commonly used in the plumbing, gasfitting and electrical trades. It was located behind the burnt-out cargo barrier frame on top of the remains of a metal tool box which contained burnt portable drilling equipment and larger mechanical tools.

The cylinder and torch, along with the remains of the tool box, the other equipment and combustible materials at the front of the van, had been damaged by the fire which followed the blast in the forward part of the wreckage. There was no residual propane in the cylinder. All the elastomer seals and o-rings in the torch and cylinder unit had been partially destroyed by heat.

Investigation at TestSafe of Assembled parts involved in the explosion
