New Safety Railing Rigorous Testing Procedure

By Laurie Gerisch, Senior Technical Officer, TestSafe Australia and Melissa Bowering, Work Experience Student, Sydney University Faculty of Economics

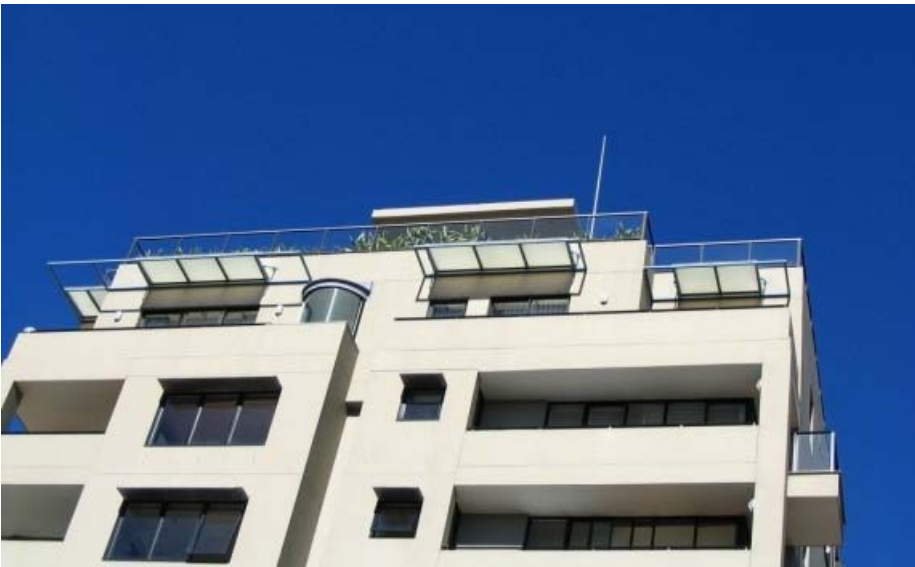
High rise building with glass infill safety railings

Recently it has become fashionable to use railings with glass in-fill panels instead of standard railings with a mid-rail. They are aesthetically more pleasing to the eye. But are they safe? and do they comply with Australian Safety Standards?

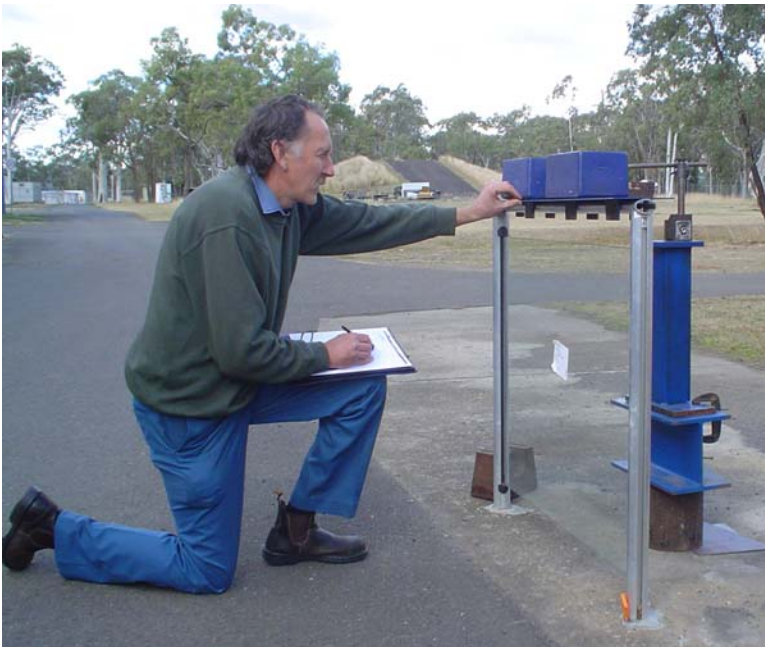
Laurie Gerisch testing glass railing at TestSafe.

Further distributed and point load tests were also conducted on the glass panel itself.

In the distributed load test a force of 840N or around 86kg was applied. With zero set at +15mm, a deflection of 11.8mm at full load was noted. After 15 minutes at full load, the natural deflection was up to 12.0mm. After the load was removed, the deflection was at a mere 14.7mm, resulting in a permanent set of 0.3mm.

The point load test applied a force to the middle of the panel of 0.5kN or around 51kg. With the initial deflection at 12.3mm increasing slightly to 12.4mm

after being held for 15 minutes, the glass moved back to 0.15mm after the load was removed.
