What Drives Non Destructive Wire Rope Examination

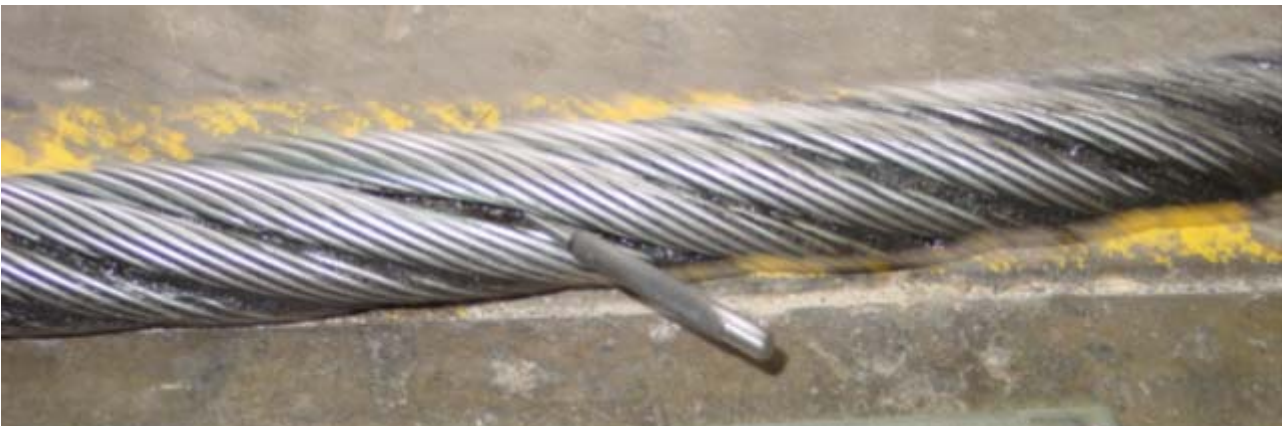
Typical Mine Drift Rope during examination.

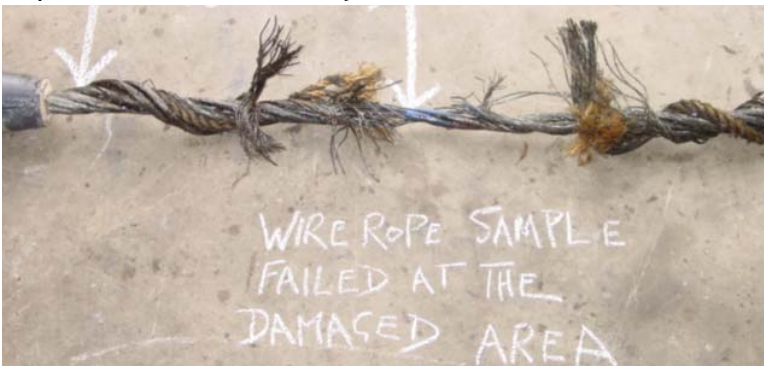
An analysis of the test chart indicated that severe corrosion and/or wear existed over a four to five metre length of the rope which, when assessed in conjunction with the measured loss of metallic area, allowed a conclusion that the rope had a potential loss in excess of fifty five percent of its' original strength. A thorough visual inspection of the rope surface showed no difference between the area of concern and the remainder of the rope. Naturally the Mine Engineer questioned the results that were being obtained and requested an explanation as to how a rope could deteriorate to the extent that it had over such a short period of time. With the winder now being operated from the winder house, the rope was passed through the test equipment several times with no change to the result. I concluded that the section of damaged rope had been constantly contaminated with mine water, over a prolonged period of time,

Mine Winder Rope following destructive rope testing

when the Dolly Car was in the parked position at pit bottom. To ensure that this conclusion was valid, the rope was marked with paint, and the Dolly Car was slowly wound to pit bottom as we followed the rope's marked section down the drift. As the Dolly Car parked it became obvious that a stream of water flowed from the roof, striking the rope on the marked section.

The results of the test were accepted immediately by the mine personnel and plans were made to immediately discard the rope and replace it with a spare from the mine's store. The mine management however, retained sufficient doubt so as to request that we return to the mine the following day, pick up the questionable section of rope that was to be cut from the body of the rope upon removal from the mine and return it to TestSafe for tensile testing. The colliery's Engineer rang the next day to apologise that he was unable to give us the sample as, during the extraction of the rope from the drift, the rope had broken **"right in the middle of the painted marking"**.
