All Hail - Nature At It's Most Damaging

Alan Whitehead, Facilities Manager, TestSafe Australia

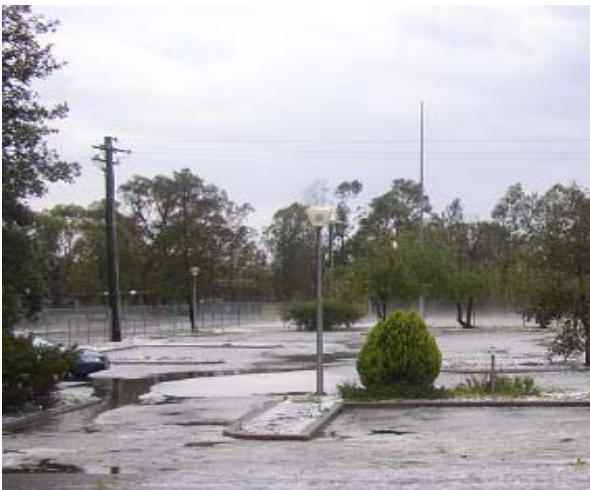
TestSafe drenched and damaged by the Spring Storm

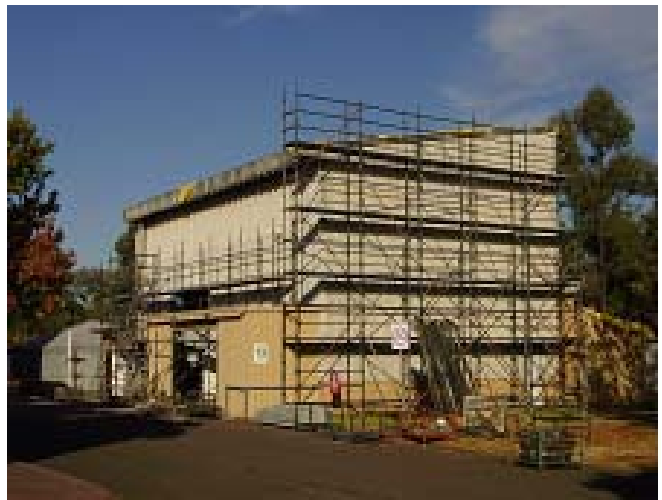
TestSafe's Mechanical Testing Building becomes Asbestos free (note the worlds biggest asbestos eaves gutter)

Finally, repairs commenced on 27 April 2004 and were completed on 27 July, two weeks ahead of schedule. In addition to the hail damage repairs totalling \$422,895, the opportunity was taken to remove as much as practical of the remaining asbestos cement based cladding materials that remained at TestSafe, in the process. This included the removal and replacement of roof soffits, fixed louvre vents, raked ceiling panels and external wall claddings and insulation materials. A number of unforeseen surprises came to light with the stripping of roofing and ceiling materials, such as old termite damage, damaged electrical wiring and non-conforming fluorescent light fittings. These remedial works consumed a further \$112,860 from maintenance funding. (It's a

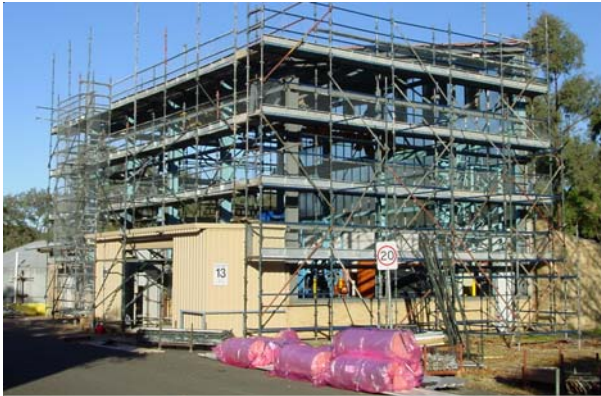
Building 13 roof and cladding stripped

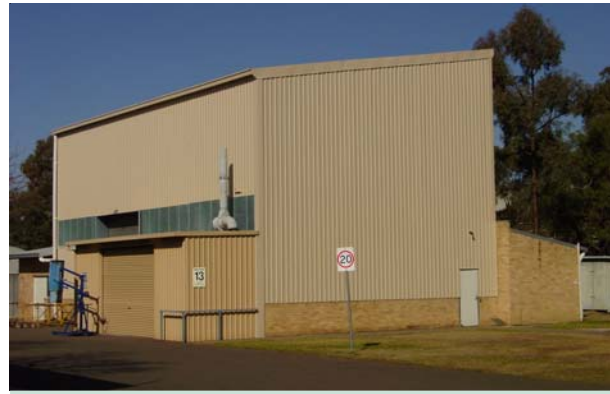
Building 13 completed with colourbond roofing and walls

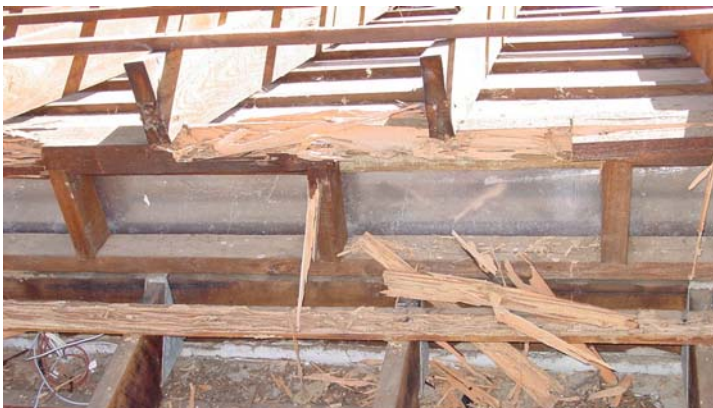
Building 8 old termite damage revealed by the storm

shame termites don't appear to suffer from asbestos related respiratory complaints).

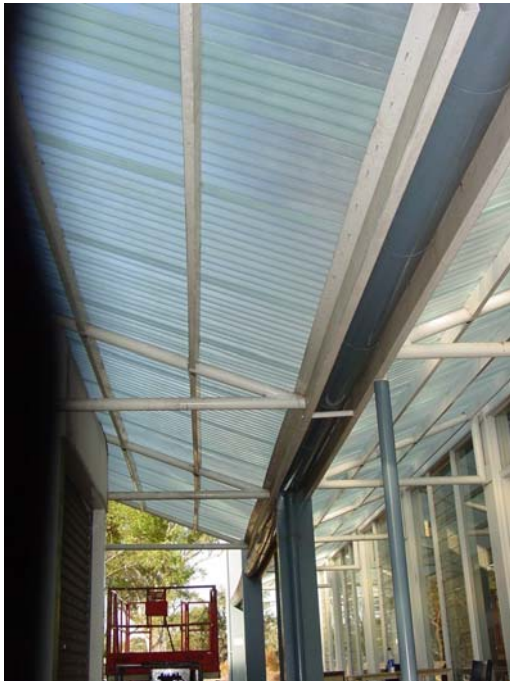
Building 17 rear awning roof replaced

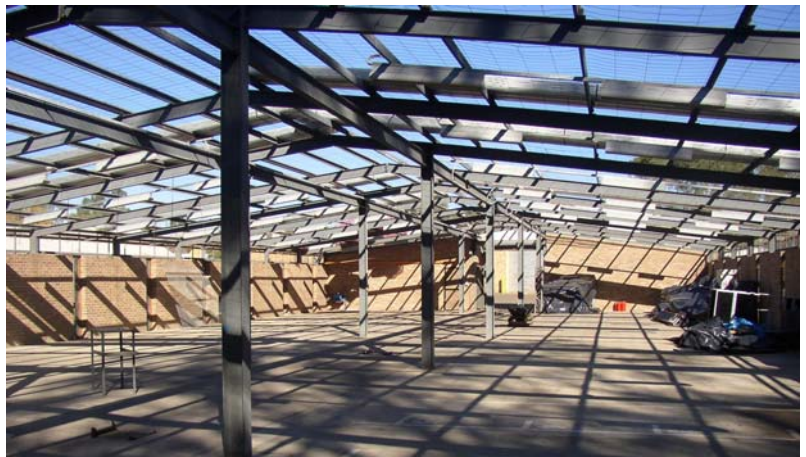
Building 10 after removal of asbestos roof cladding

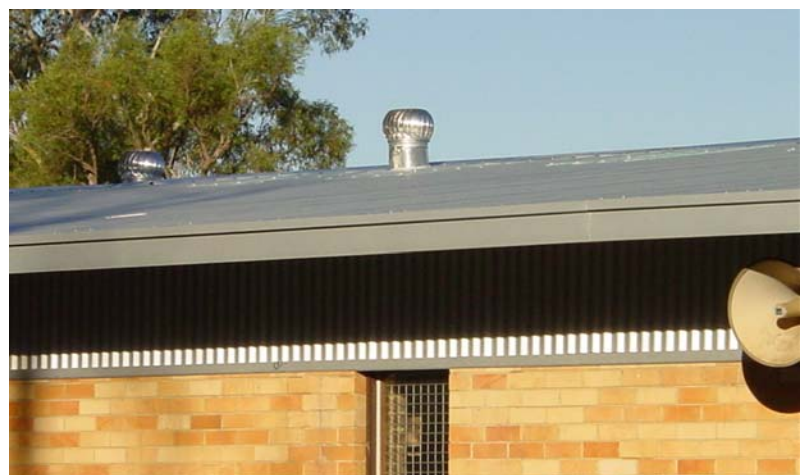
Building 10 showing new roof and vent with side AC louvre vents replaced with fixed cladding

All-in-all, not only have existing and potential health hazards been removed from affected buildings, but the physical appearance of many of the buildings has been enhanced and the internal natural light values in Buildings 10 and 13 have been substantially improved.
